Daigh Company Job Stories

#23a Pre Split for Subway Project Queens NY

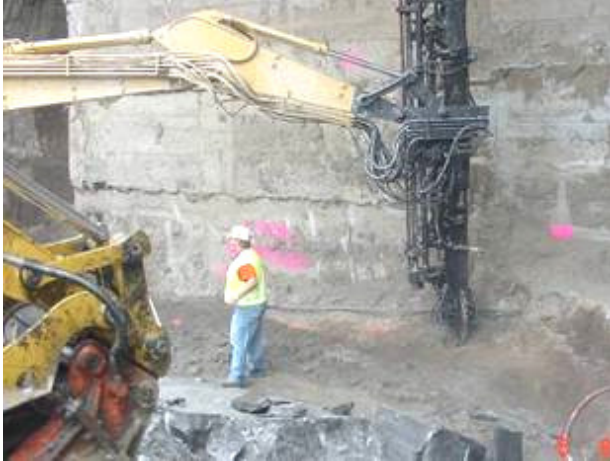
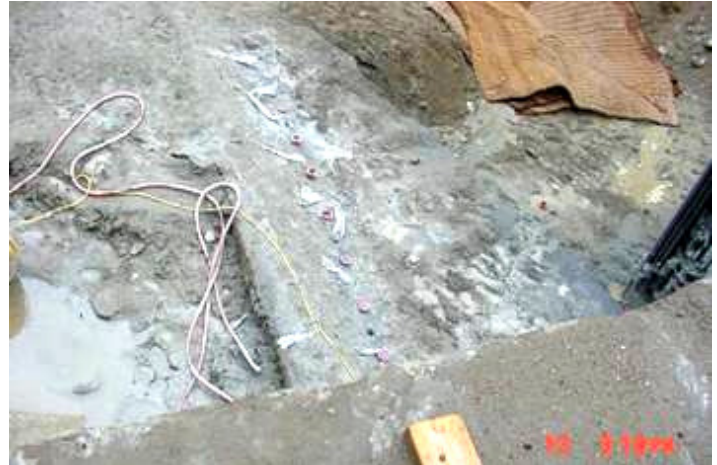
2 3/4" holes were drilled with depth up to 24 feet on 1 ft centers 3 ft from existing subway wall. Every other hole was loaded,

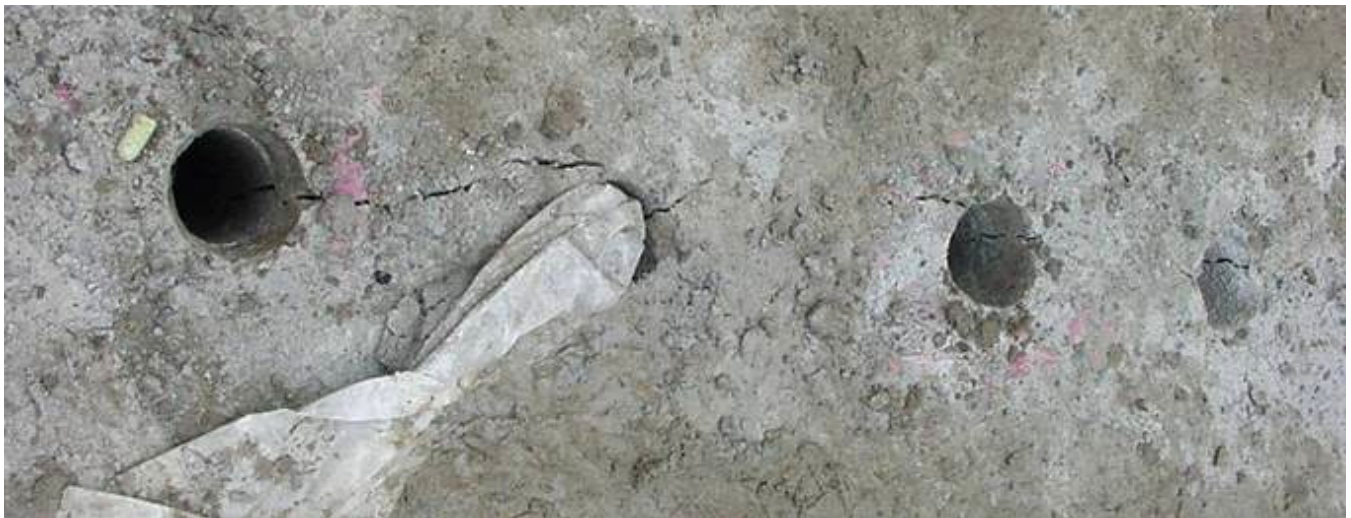
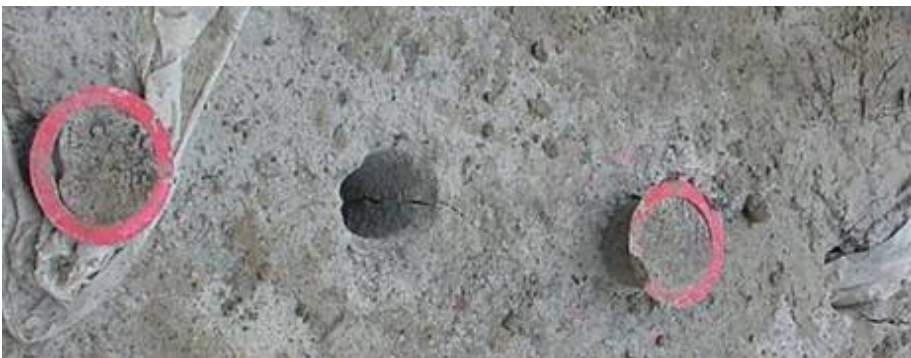
Cracking occurred from hole to hole full depth. Dā-mite was loaded in sleeved holes due to wet conditions in the holes.

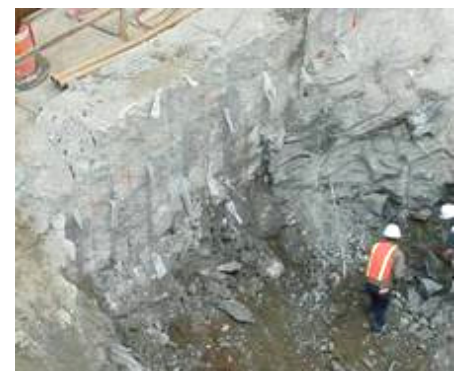
Note the clean break line that was achieved from the Dā-mite after blasting.
