JOB STORY

Mass Rock:
Basement Excavation
Commercial Bethesda, MD

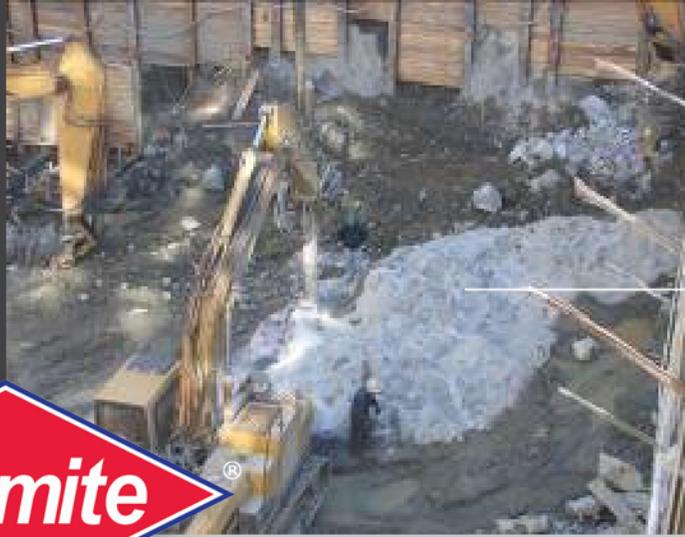
Rock to be removed.

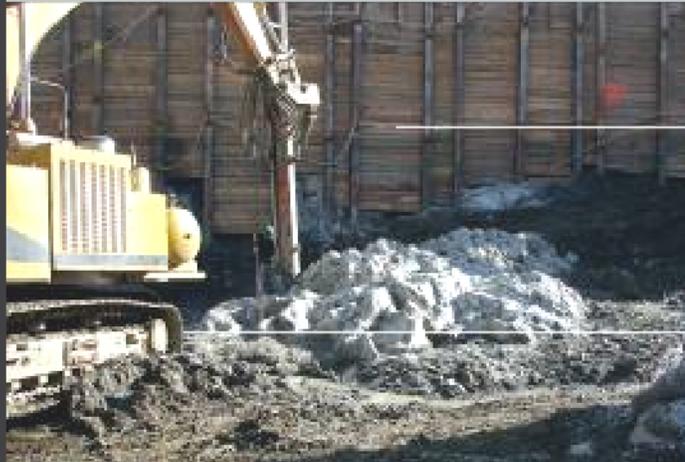
Da-mite was also used on the wall to excavate rock so that tiebacks could be placed.

John Henry drilled 2.5" holes to a 8ft-11ft depth.

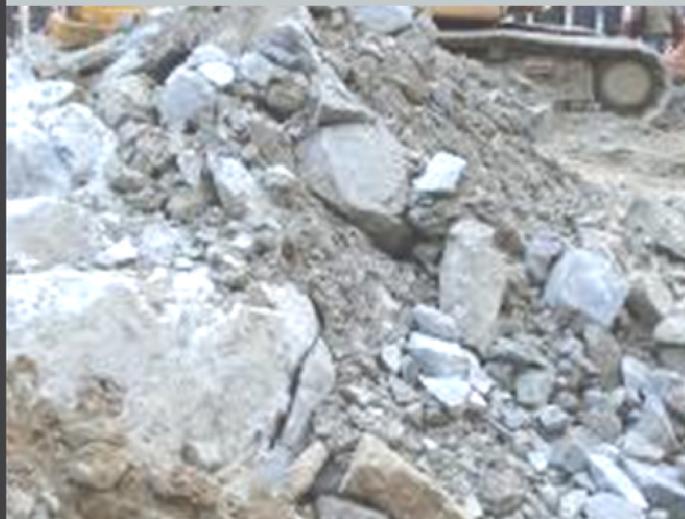
Holes loaded on Friday afternoon and cracks in rock on Monday morning.

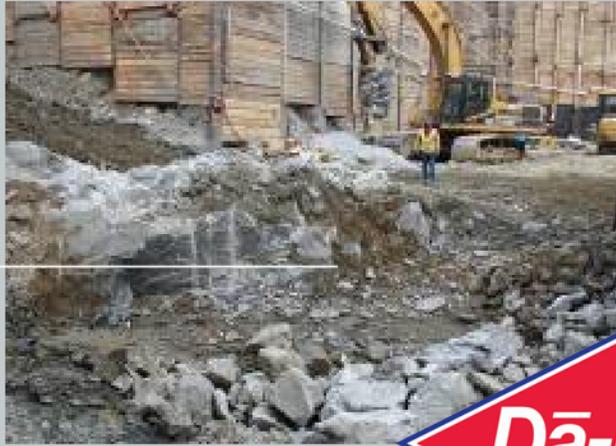
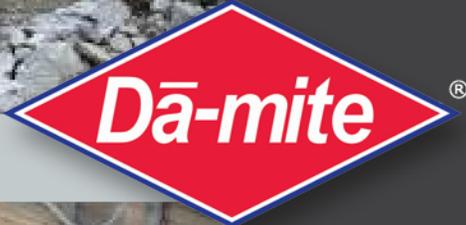
Clean cut Da-Mite used for tiebacks.

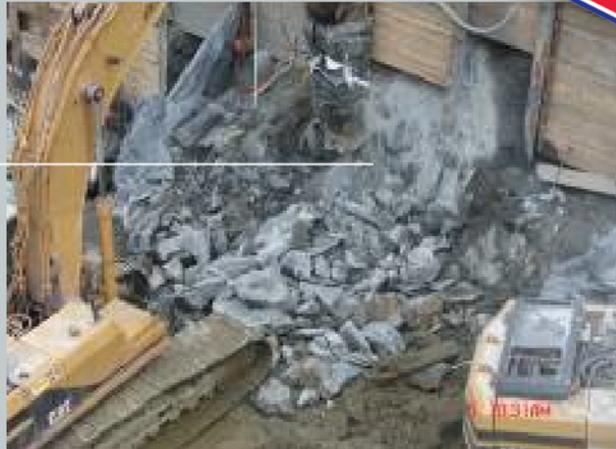
"Problem" rock is gone.
