JOB STORY

Quarry: High Wall Trimming

Trimming a high wall overhang in a Quarry for a safe passage of the access road to the quarry's rock crusher. The area drilled was approximately 90ft by 6ft wide by 10ft deep.

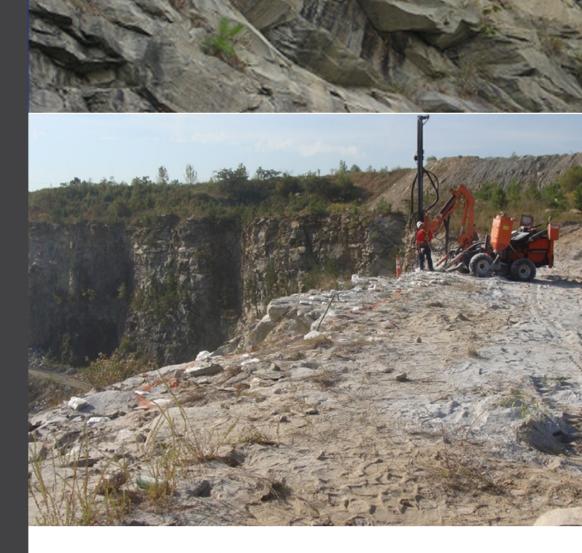
> Once a drill pattern had been determined for the most efficient way to trim the rock overhang the team begin drilling the holes.Then filling the holes with Da-mite.

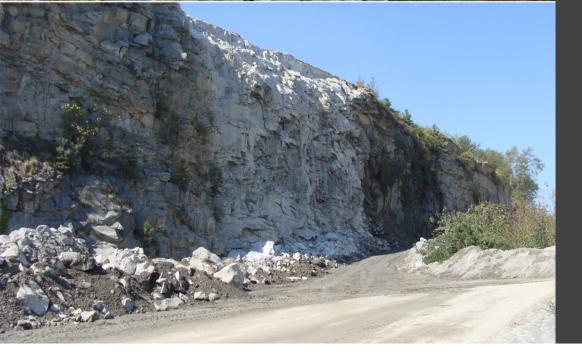
Soon after the entire face of the overhang had been removed.

All of the overhang had been removed and is no longer a burden to the access road below.
