## JOB STORY

**Mass Rock:**  
Outcropping Excavation  
Foundation

**Da-mite**

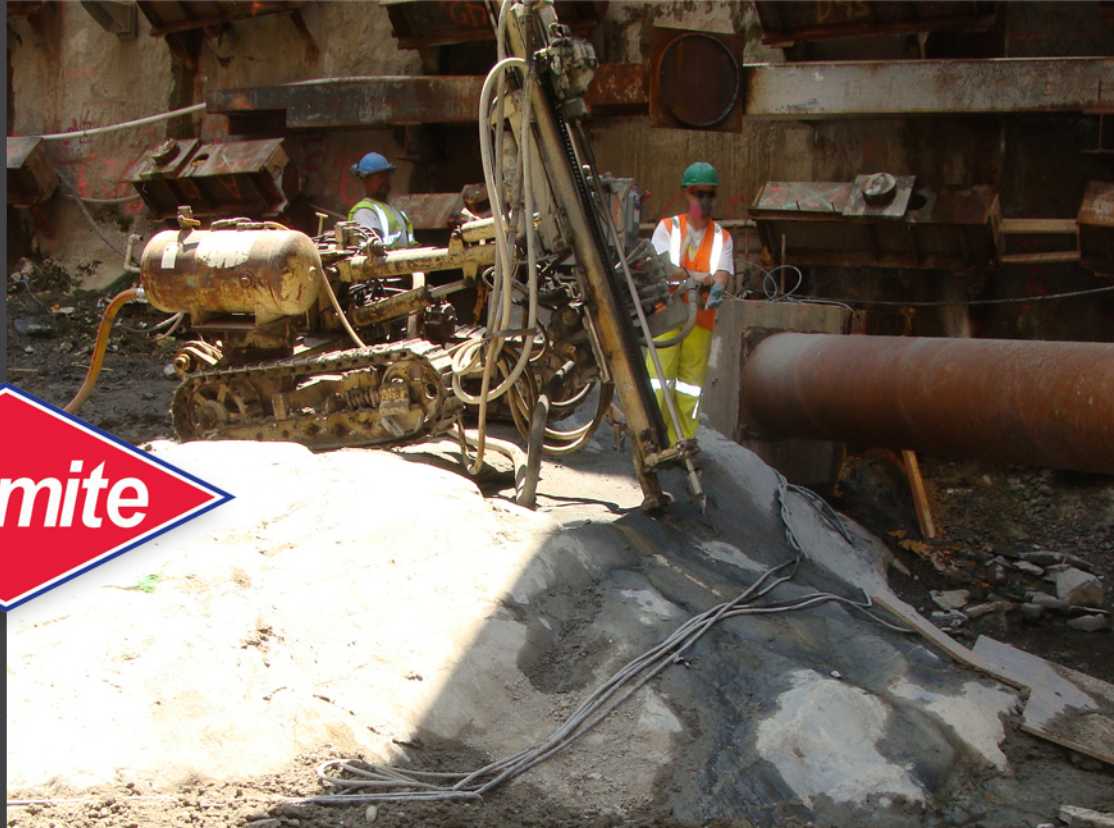
Holes being drilled with 1 7/8"  
diameter holes, 8-10' deep.  
(Top Photo)

Mass Rock/Outcropping:  
Rock: Pegmatite  
Holes drilled: 1 7/8" diameter  
holes, depth 8-10' deep  
Problem: impact hammers  
would not break the rock.  
Explosives could not be used  
due to confined space.

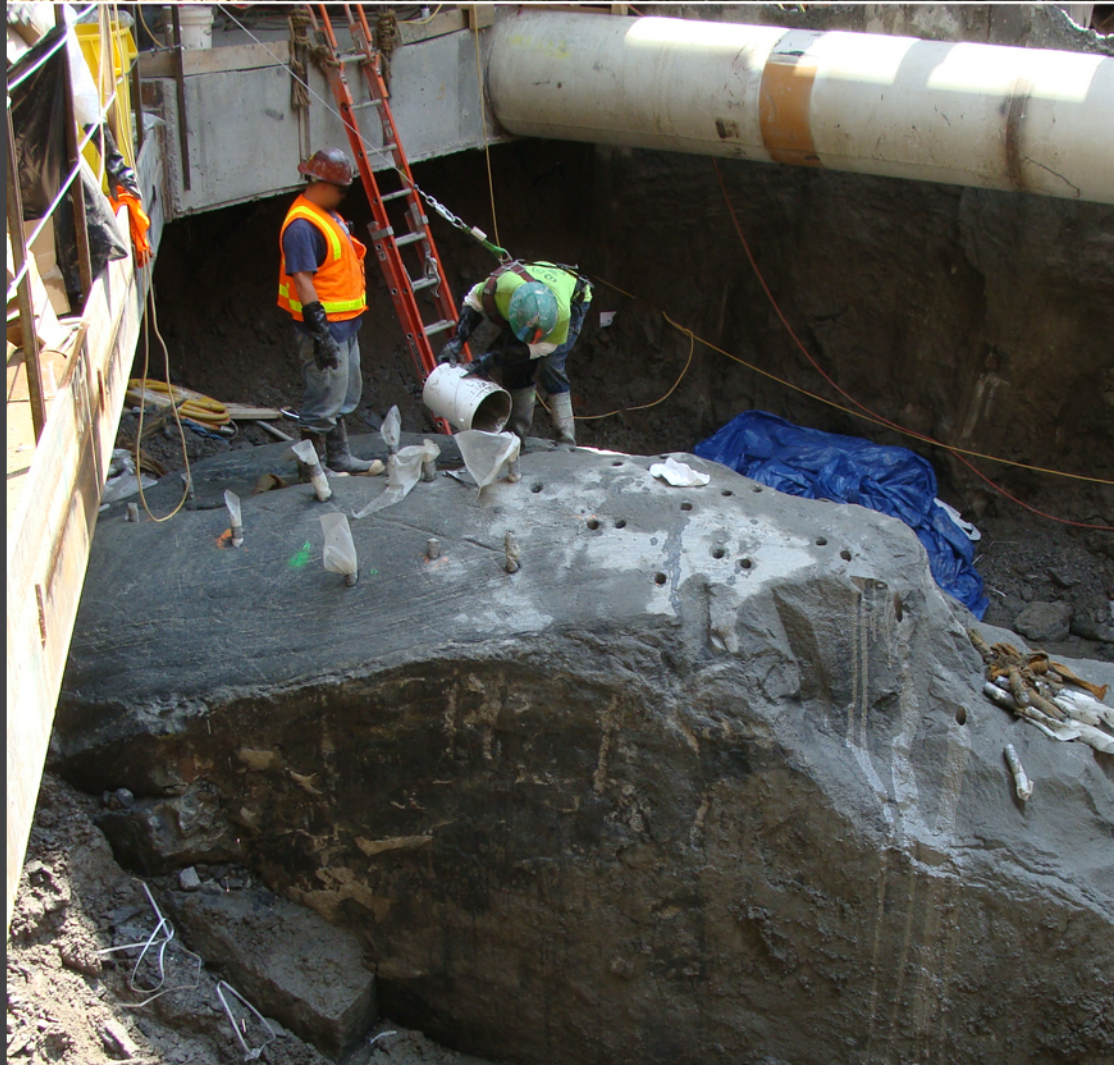
Workers pouring Da-mite  
into the holes at 2pm in the  
afternoon.

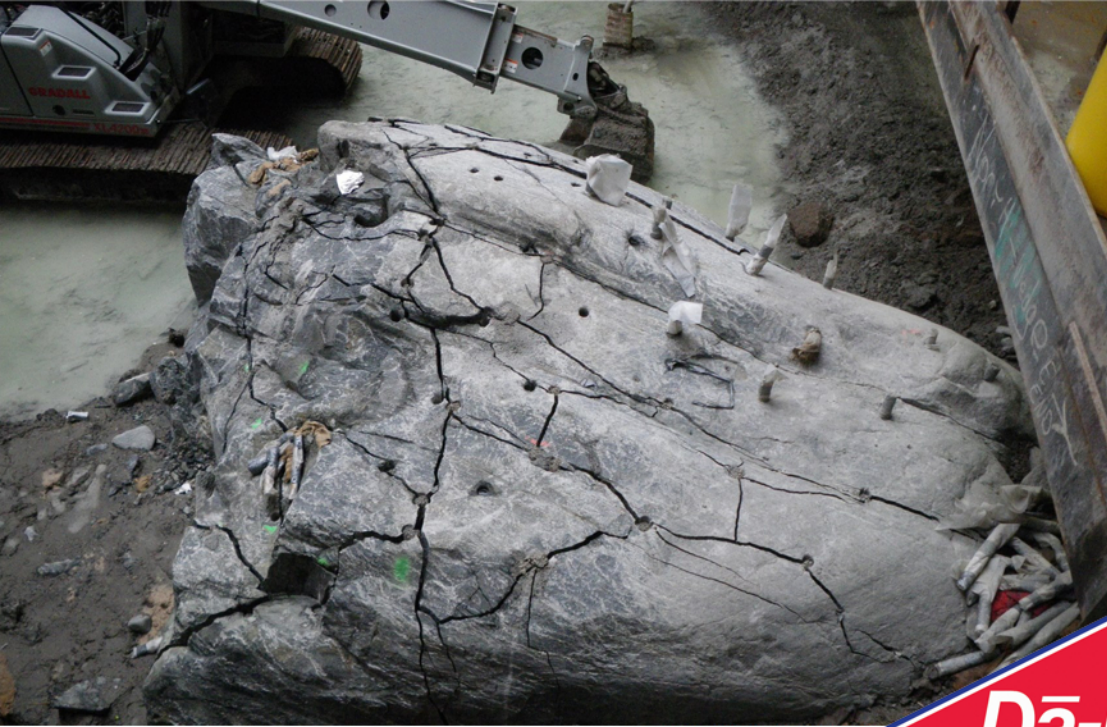
Rock fractured by Da-mite within 18 hours.

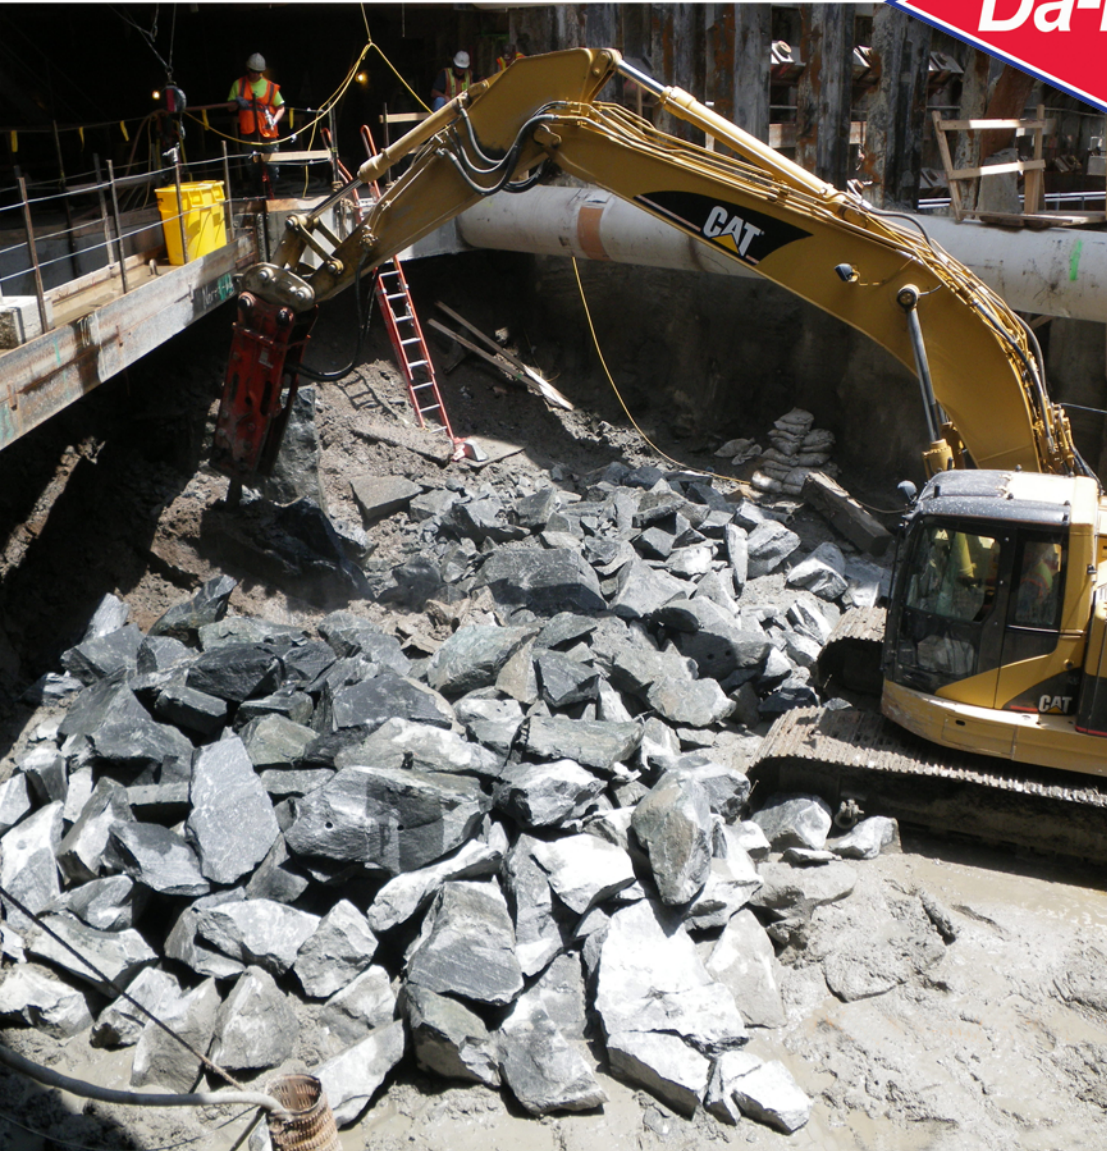
Contractor able to break down and excavate the rock within minutes after Da-mite fractured the rock.
